COOLING SYSTEM

MECHANICAL SEAL/BEARING REPLACEMENT

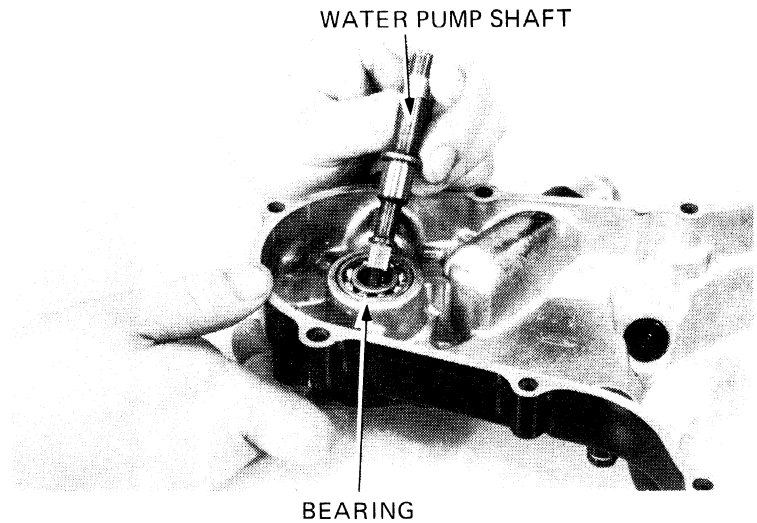
Check the water pump shaft for any damage.
Check the water pump shaft bearing in the right crankcase cover for excessive play or damage.

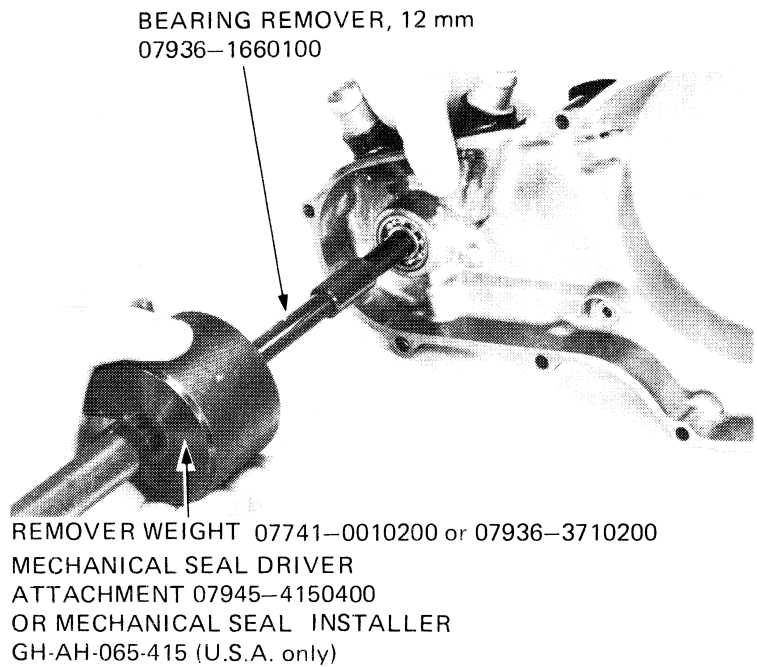
Remove the bearing with a bearing remover.
Remove the oil seal, then drive out the mechanical seal.

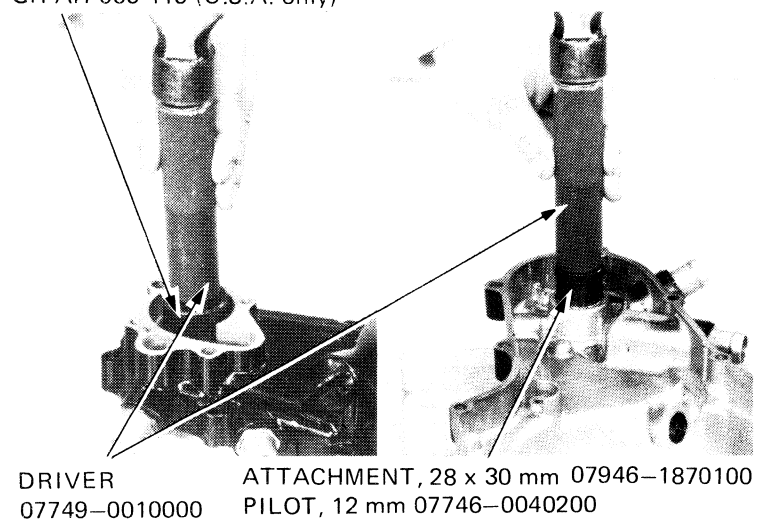
Drive a new mechanical seal carefully into the right crankcase cover.

Be careful not to damage the cover when driving the mechanical seal, into the cover.

Install a new oil seal and drive a new bearing in the right crankcase cover.
