NSR250R(K)

CARBURETTOR SOLENOID TUBE INSPECTION

VALVE LEAK INSPECTION

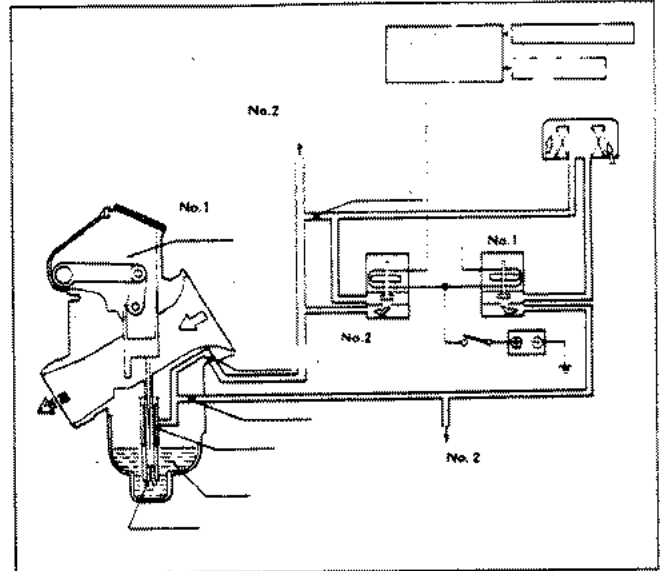
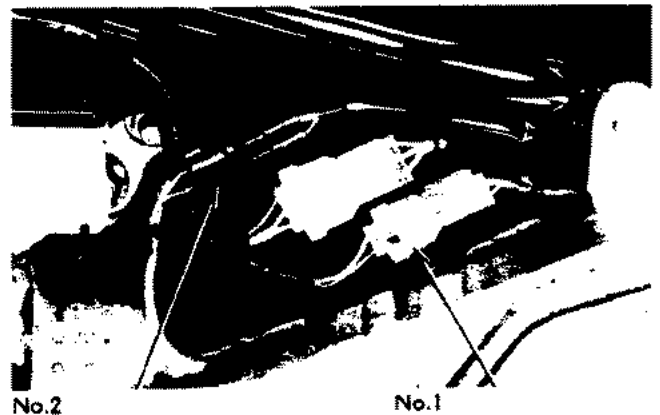
- Remove seat cowl
- Remove fuel tank (4.2)
- Remove air cleaner case (20.29)
- Inspect for wear and damage to tube leading from solenoid to carburettor and joint
- Refer wiring diagram (22.11) and inspect routing

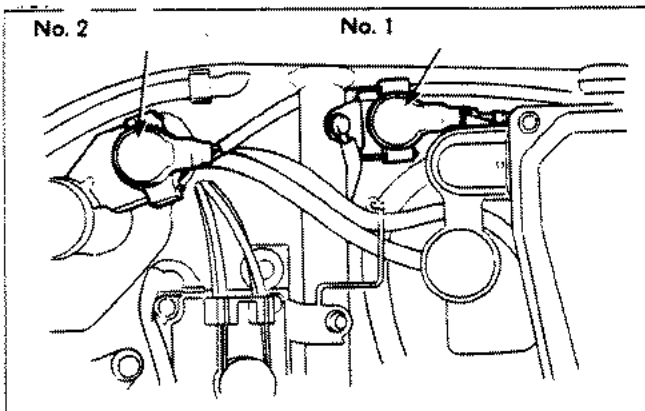
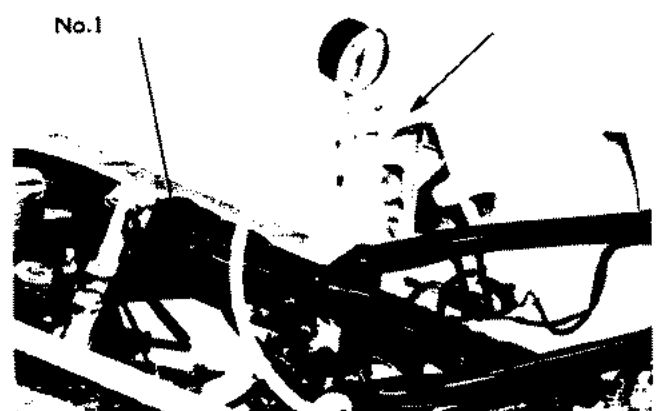
- Remove air cleaner case (20.29)
- Remove No.1-2 solenoid 2P coupler connection
- Remove bottom tube from No.1 solenoid
- Apply pressure to bottom of solenoid and if it will hold it is okay

* Do not apply more than 30mm Hg pressure

- If it does not hold, then replace solenoid
- Inspect No. 1 solenoid in the same way
- Connect solenoid 2P coupler, turn on main switch and inspect in the same way as above. If it can hold pressure, then it is okay. If it cannot then inspect engine control unit and wire harness
