Wire harness inspection

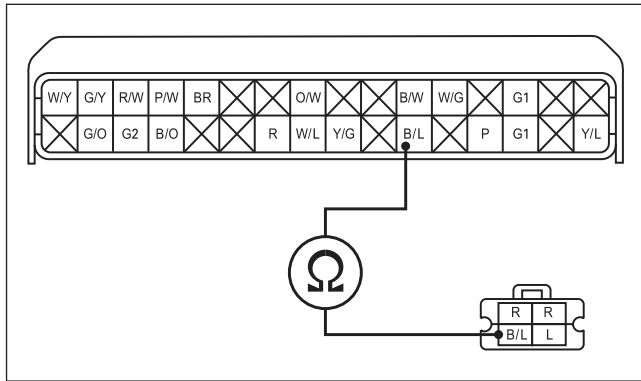
Check for continuity of the Black/Blue wire between the fan motor relay 2P (Natural) connector and ECM 32P (Black) connector. There should be continuity. If there is no continuity, repair or replace the wire harness.
