Tail/stoplight Bulb Replacement

Decarbonizing

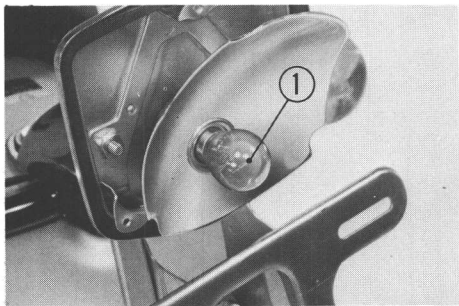
1. Remove the two screws retaining the tail/stoplight lens.
2. Press the bulb ① inward and twist to the left and the bulb can be removed.
3. Replace with a good bulb.
4. Reinstall tail/stoplight lens.

① Tail/stoplight bulb
