Brake Wear Indicator

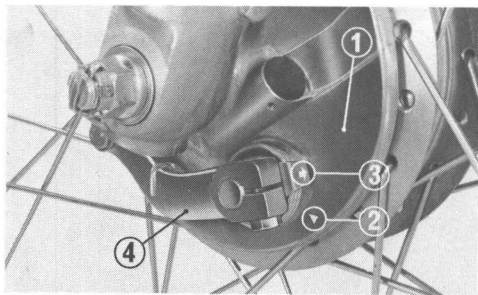
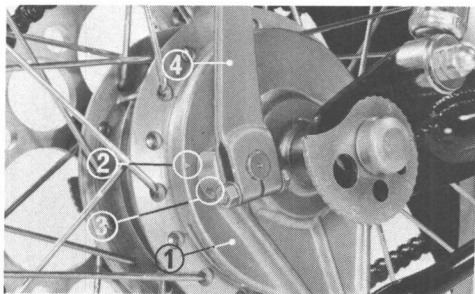
On the TL125, the wear indicator is provided in the front and rear brakes. When the brake is applied, an arrow ③, adjacent to the brake arm ④, moves toward a reference mark ② on the brake panel ①. The distance between the arrow and the reference mark, on full application of the brake, indicates brake lining thickness. If the arrow aligns with the reference mark on full application of the brake,

replace the brake shoes.

| ① Brake panel | ③ Arrow |
| ② Reference mark | ④ Brake arm |

NOTE: When brake service is necessary, or when brake adjustment is impossible (refer to pages 48~50), see your authorized Honda motorcycle dealer. When replacing brake shoes, install only genuine Honda parts.
