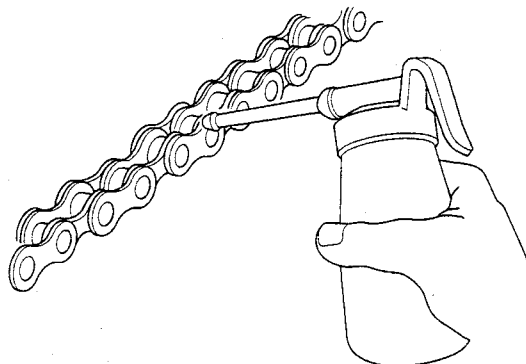
D.I.D. 520V8 or RK 520MOZ6

The O-rings in this chain can be damaged by steam cleaning, high pressure washers, and certain solvents. Clean the side surfaces of the chain with a dry cloth. Do not brush the rubber O-rings. Brushing will damage them. Wipe dry and lubricate only with SAE 80 or 90 gear oil. Commercial chain lubricants may contain solvents which could damage the rubber O-rings.
