Electrical servicing

Chapter lights / instruments / switches (2ED)

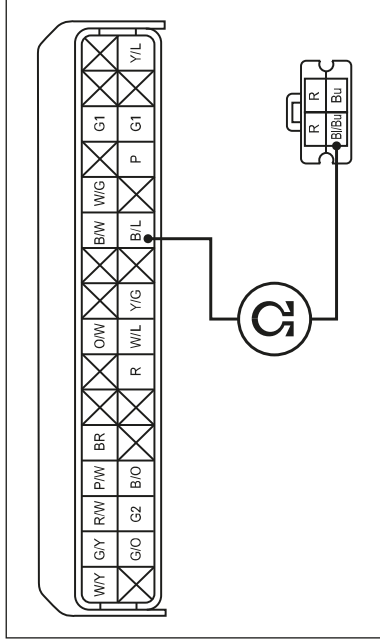
Wire harness inspection

Check for continuity of the Black/Blue wire between the fan motor relay 2P (Natural) connector and ECM 32P (Black) connector.

There should be continuity.
If there is no continuity, repair or replace the wire harness.
