## COOLING SYSTEM

## SECONDARY AIR SUPPLY SYSTEM

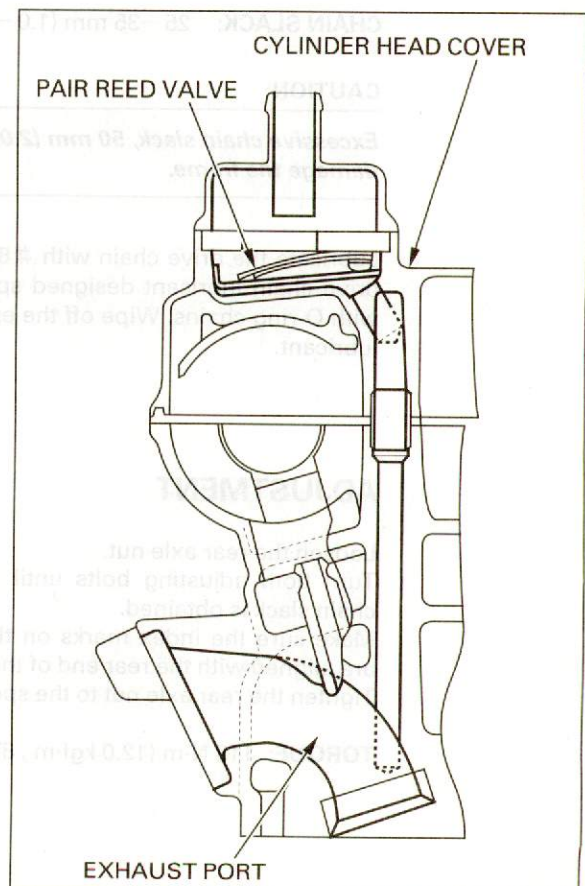
Check the PAIR (pulse secondary air injection) tubes between the PAIR control solenoid valve and cylinder head cover for deterioration, damage or loose connections. Make sure that the hoses are not cracked.

If the hoses show any signs of heat damage, inspect the PAIR check valve in the PAIR reed valve cover for damage.
