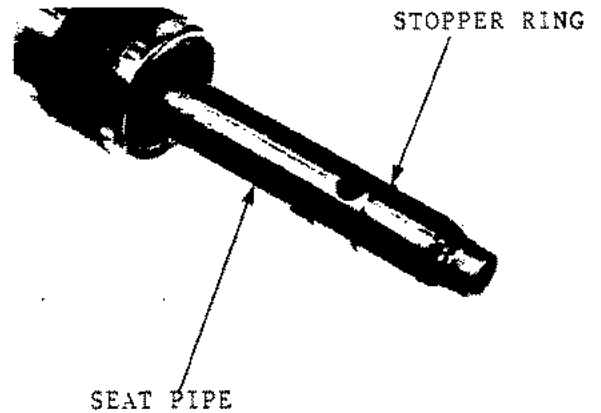
Remove stopper ring from seat pipe

Remove seat pipe from fork pipe

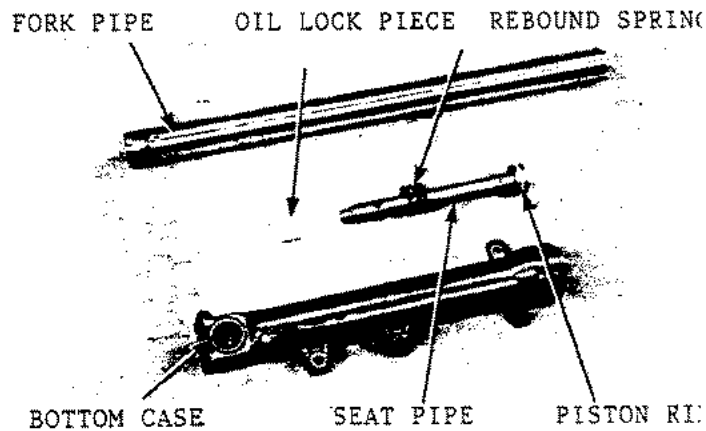
Inspect fork pipe, seat pipe, oil lock piece, rebound spring, bottom case and piston ring for wear and damage

Replace if any abnormalities

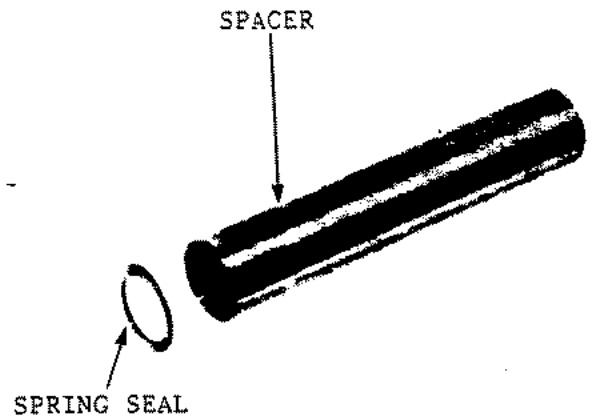
Inspect spacer, spring seat for damage.
If any then replace
